Maryland Historical Trust State Historic Sites Inventory Form

historic Fischer House

street & number 8805 Harford Road

Survey No. BA-2762

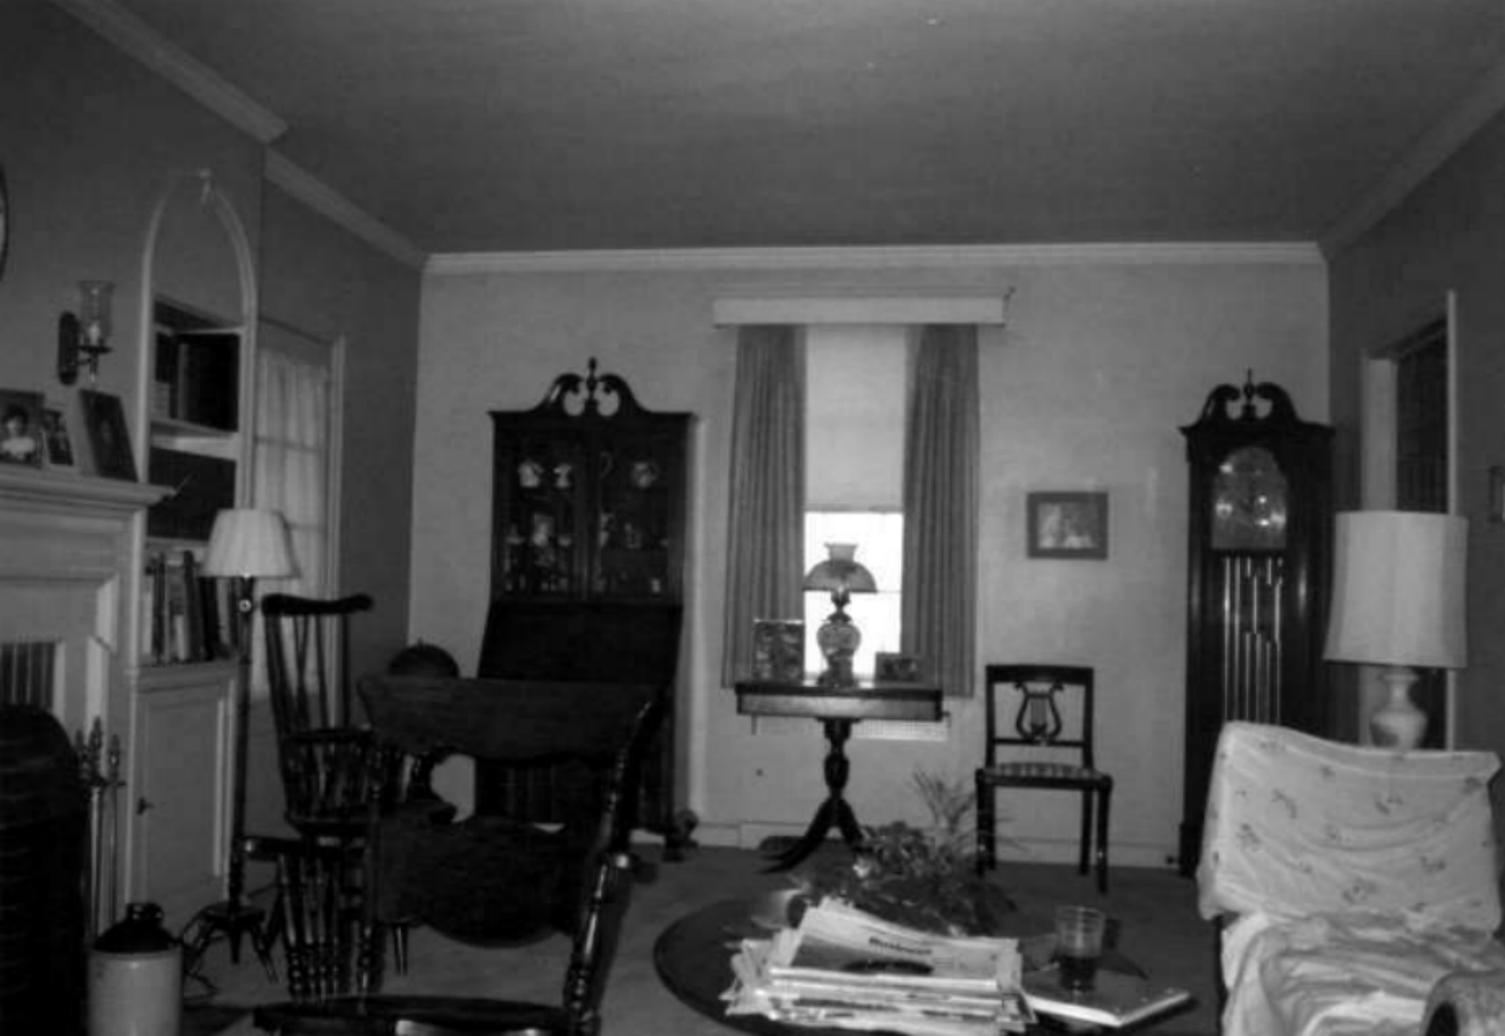
(3)

Moving into the living room from the foyer, one's first impression is of balance. Two recessed bookcases with arched moldings above them flank a fireplace with a modest mantle, which in turn are flanked by two doors which lead into the sunroom porch. The windows in the front and back of the room are placed symmetrically. The ceiling molding is rather plain. There are curtain surrounds over the front and back windows. The living room gives access to a small hallway, once the breakfast room, and leads into the kitchen¹⁰. From the kitchen, one may go directly into the dining room. This room is decorated with

INTERIOR FRONT ROOM, FACING
NORTHWEST

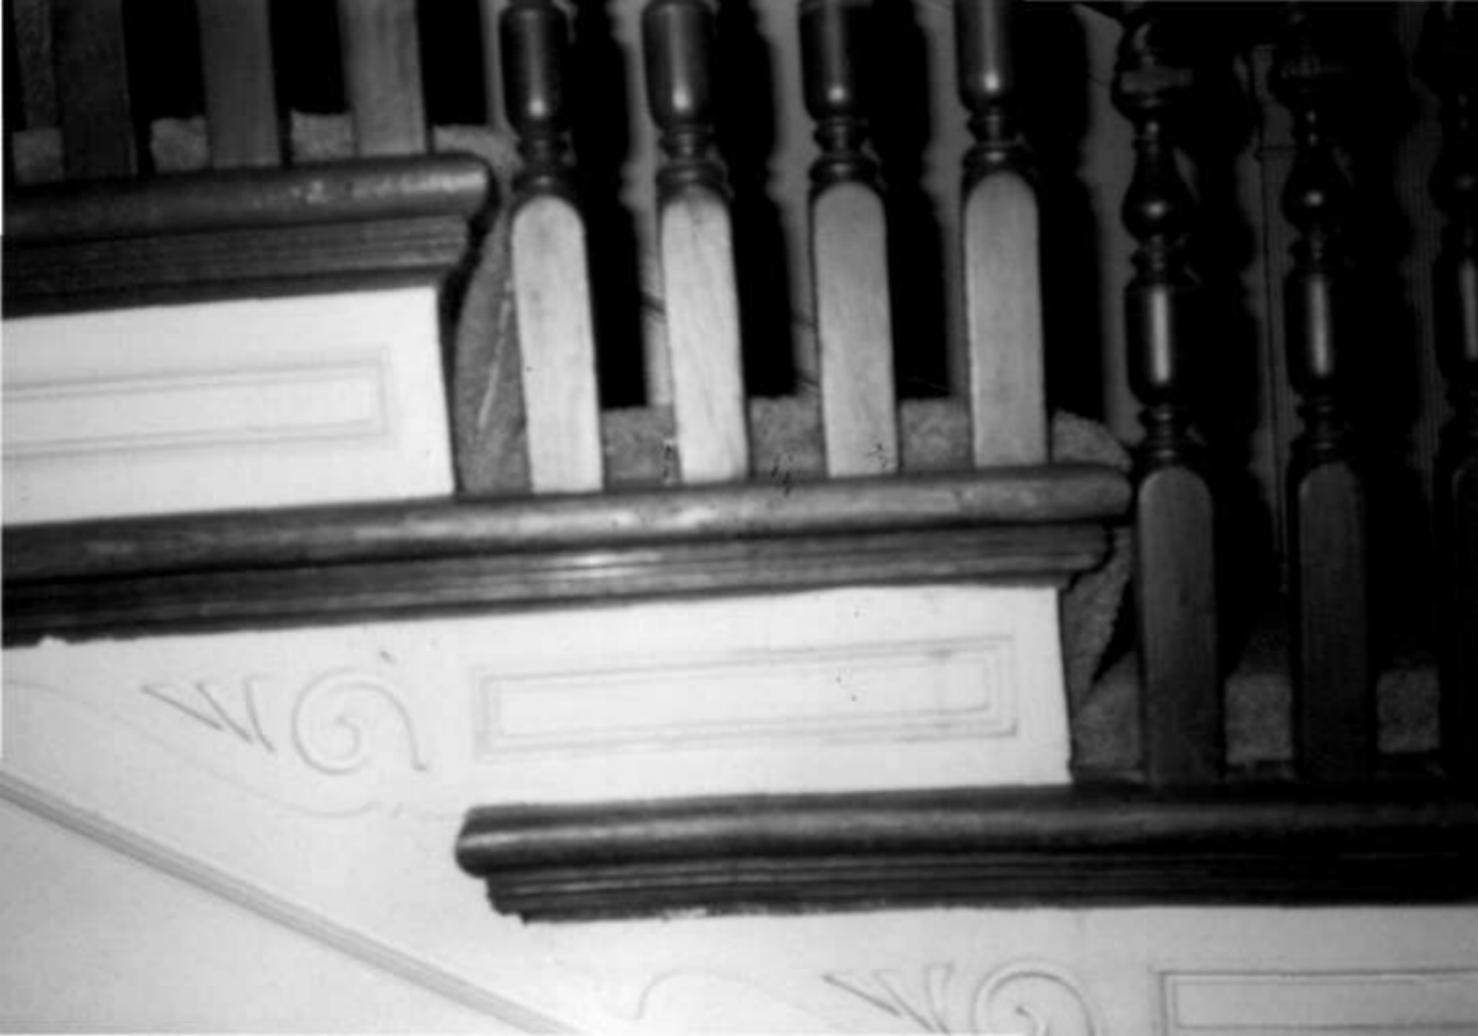
(4)

⁹ The stairway and door surrounds were salvaged from a house which was being demolished and stood on the grounds of Coppin State College on North Avenue, near Walbrook.

BA-2762
Fischer House
DETAIL OF STAIR
FACING NORTH

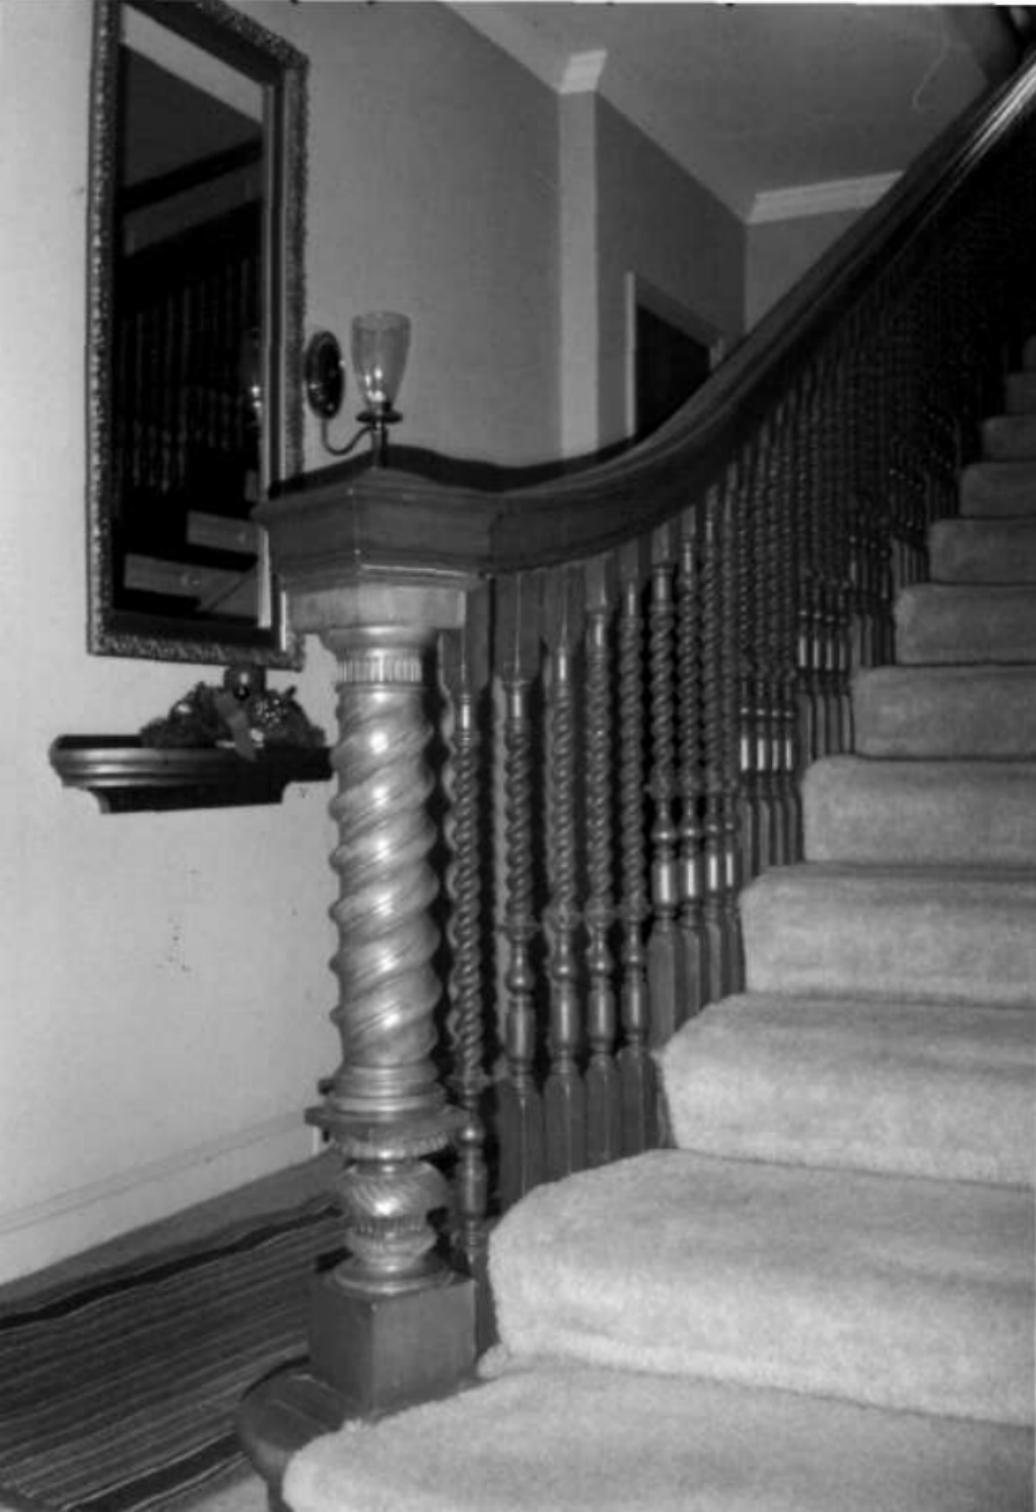
(5)

DETAIL OF NEWEL POST

FACING EAST

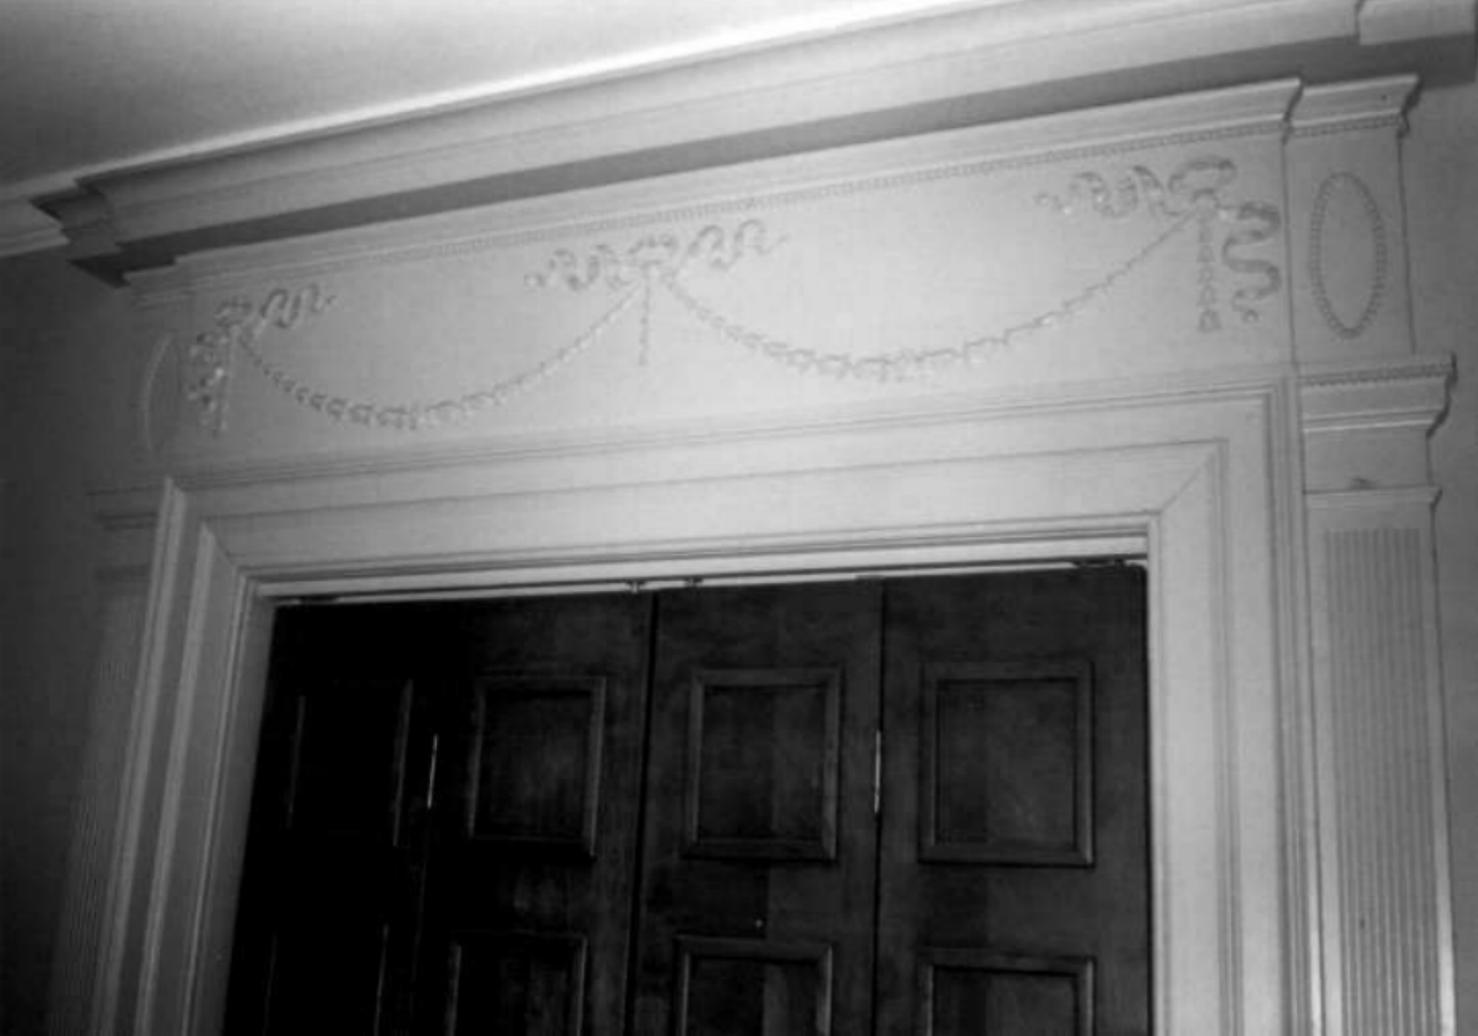
(6)

The interior of the house is extremely balanced, echoing the outside elements. From the front entrance leads directly to the foyer, and a center hall which extends to the back of the house. The stair to the second floor is located in this room. From the foyer, the dining room is accessible to the left and the living room to the right. The door surrounds⁹ of the foyer are elaborately decorated with garlands above the doorway and moldings made to look like engaged pillars extending down the sides.

Fischer House
DETAIL OF DOOR SURROUNDS IN FRONT HALL

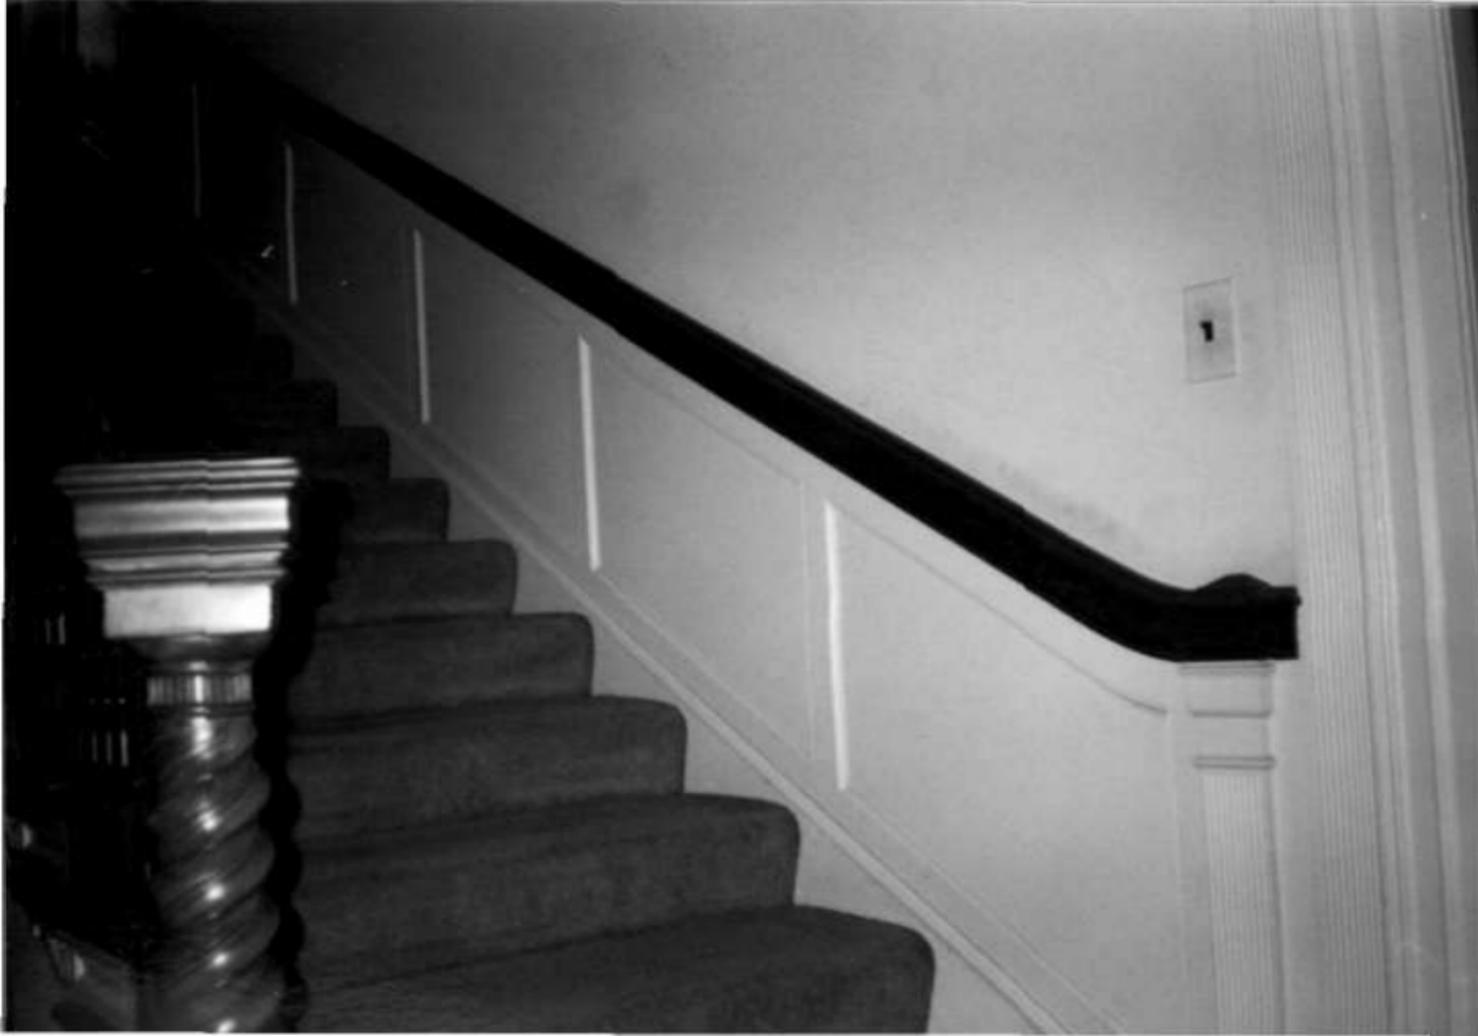
(7)

BA-2762
Pischer House
DETAIL OF STAIR

FACING NORTHEAST

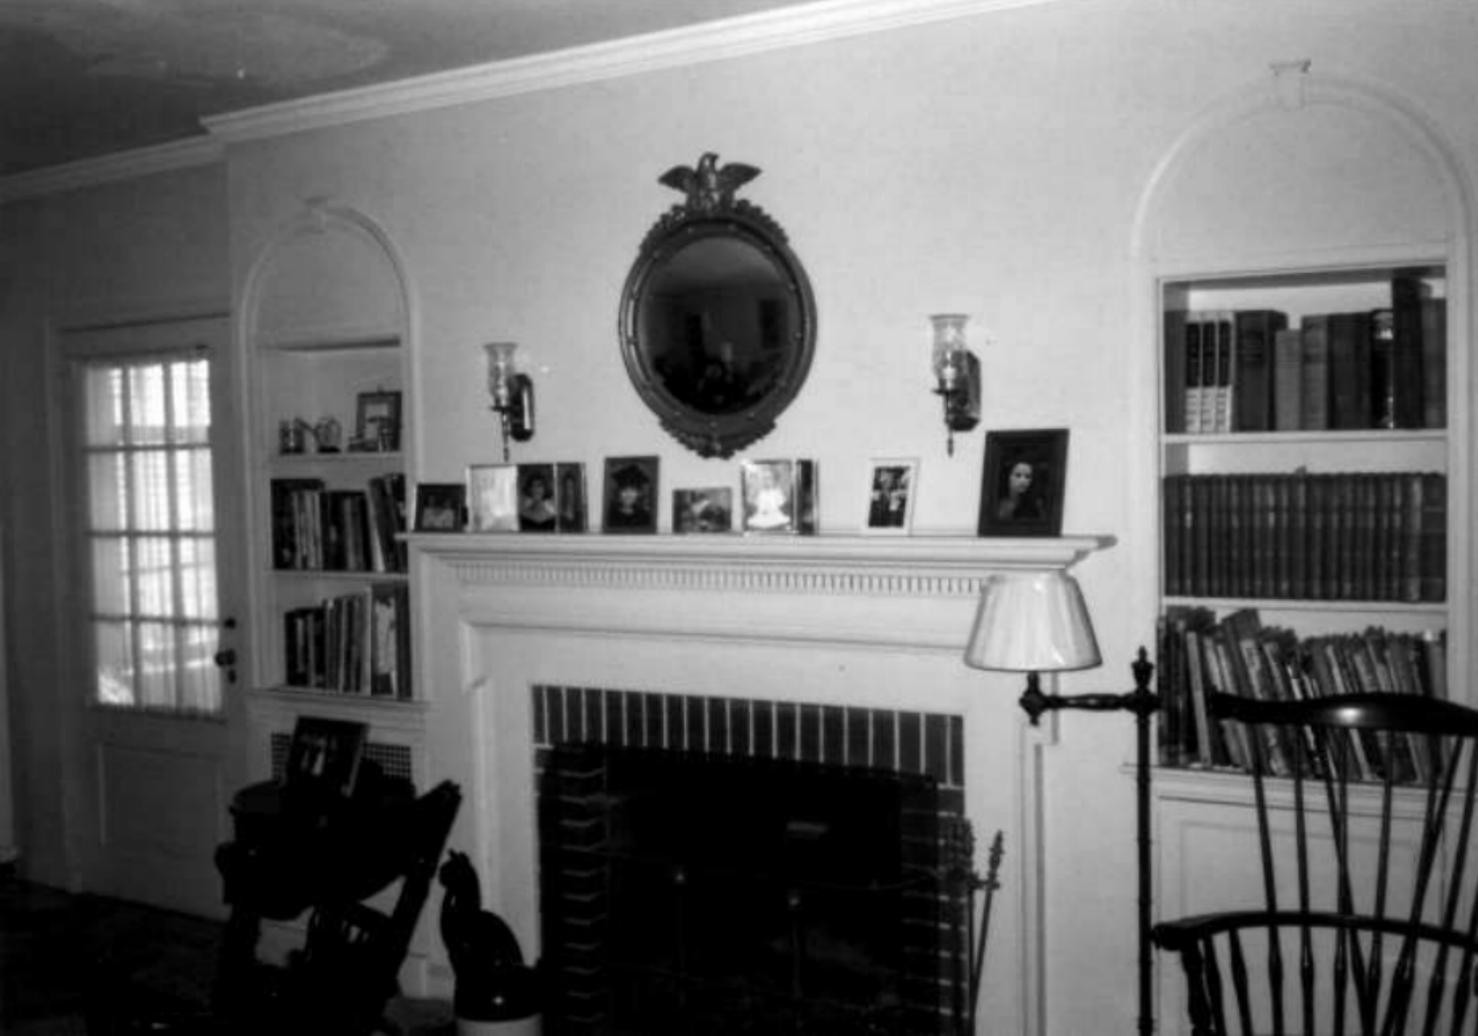
(B)

DETAIL OF ROOM (MANTLEPIECE)

FACING NORTH IN FRONT ROOM

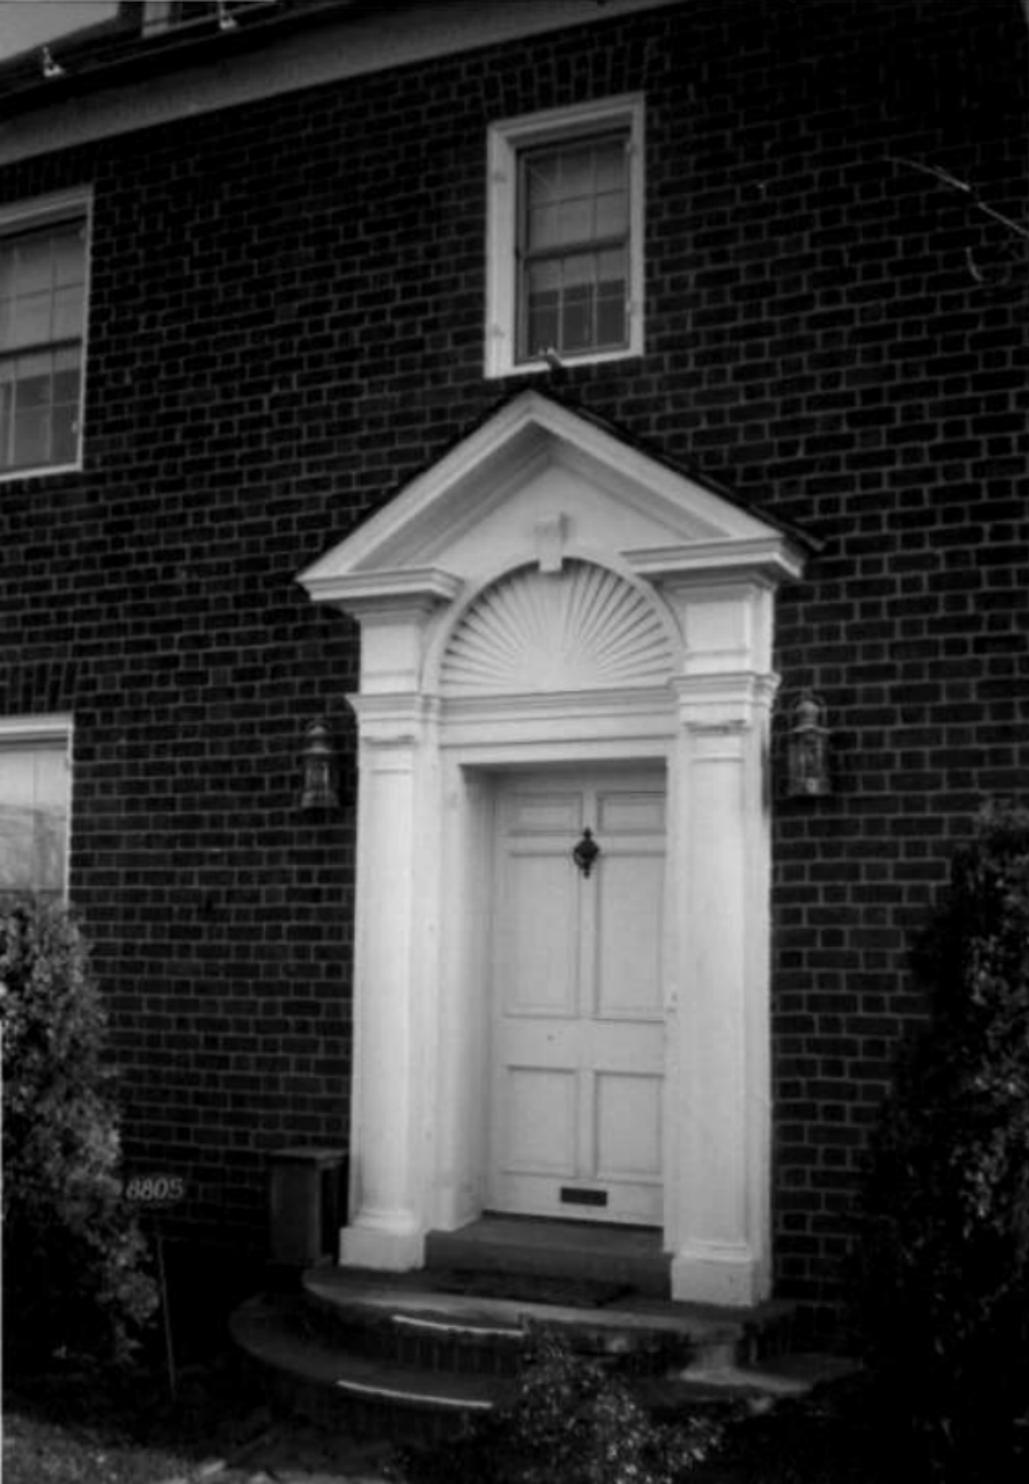
~~FACADE~~ (12)

The front entrance is set off by two semicircular bluestone steps and engaged pilasters, which have a molded cornice with a beaded garland. Above these pilasters, short caps support an interrupted pediment, which is accented by dentils on the interior edge. A wooden fan decoration reaches into the pediment space and rests on the lintel. A scroll decorates the top of the fan and also extends into the pediment. All is sheltered by a shingled overhang. The door itself is made up of six recessed panels, with the longest in the center. The soffits mirror the door with recessed paneling of their own.

BA-2762 / Fischer House
FRONT ENTRANCE WEST FACADE

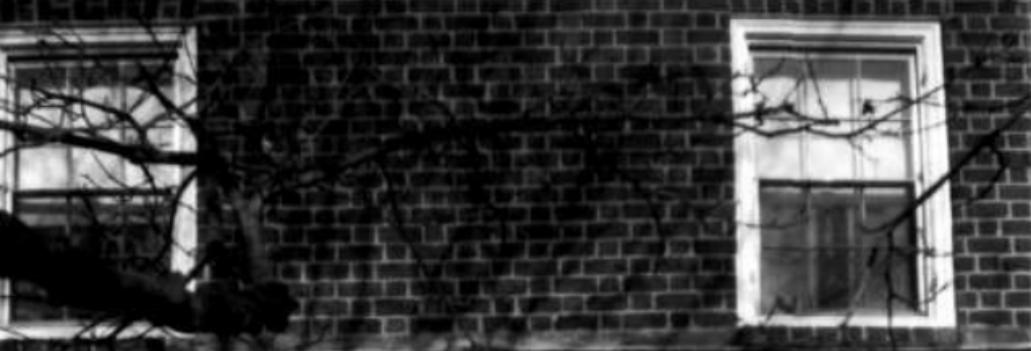
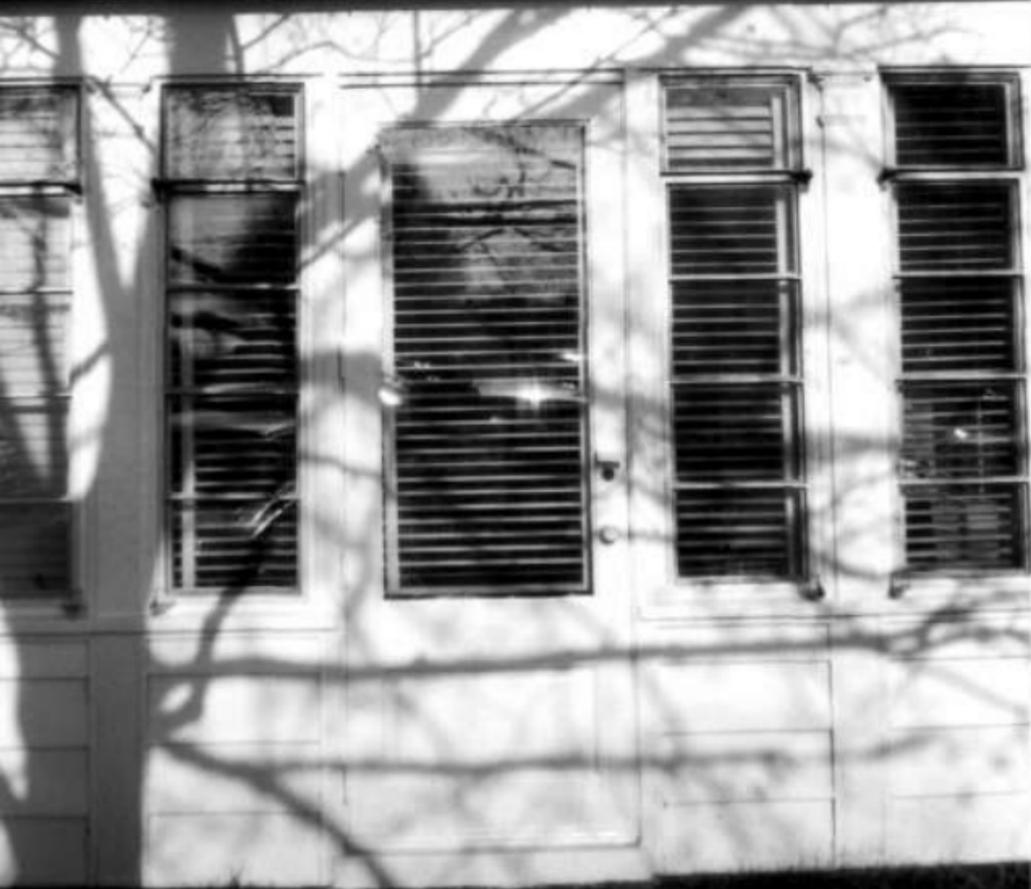
(13)

Circling to the North side facade, the most engaging element is the side porch. It is enclosed², with a sloping roof covered in asphalt shingles³. It has engaged pillars⁴ with dentils which echo the front facade. There are three large single lights, bracketed with four sidelights. The door is located in the middle, and blends into the facade by mirroring the other lights. The floor was originally brick, with a concrete foundation. Weatherboard extends roughly a third of the way up the porch. From this facade, one can see that the chimney is centered and the two windows on the second floor flank it. On the third floor, the windows are quarter circle, with four fan panes. The side of the porch which overlooks the backyard is a bay window with the same light styling as the other windows.

² The porch started its life as an open structure, but was enclosed circa 1948.

³ This roof was originally covered in Chapman slate, as the house roof still is.

⁴ These pillars supported the porch when it was unenclosed, and were built around to enclose the porch.

Fischer House
DETAIL OF PORCH

NORTH FACADE

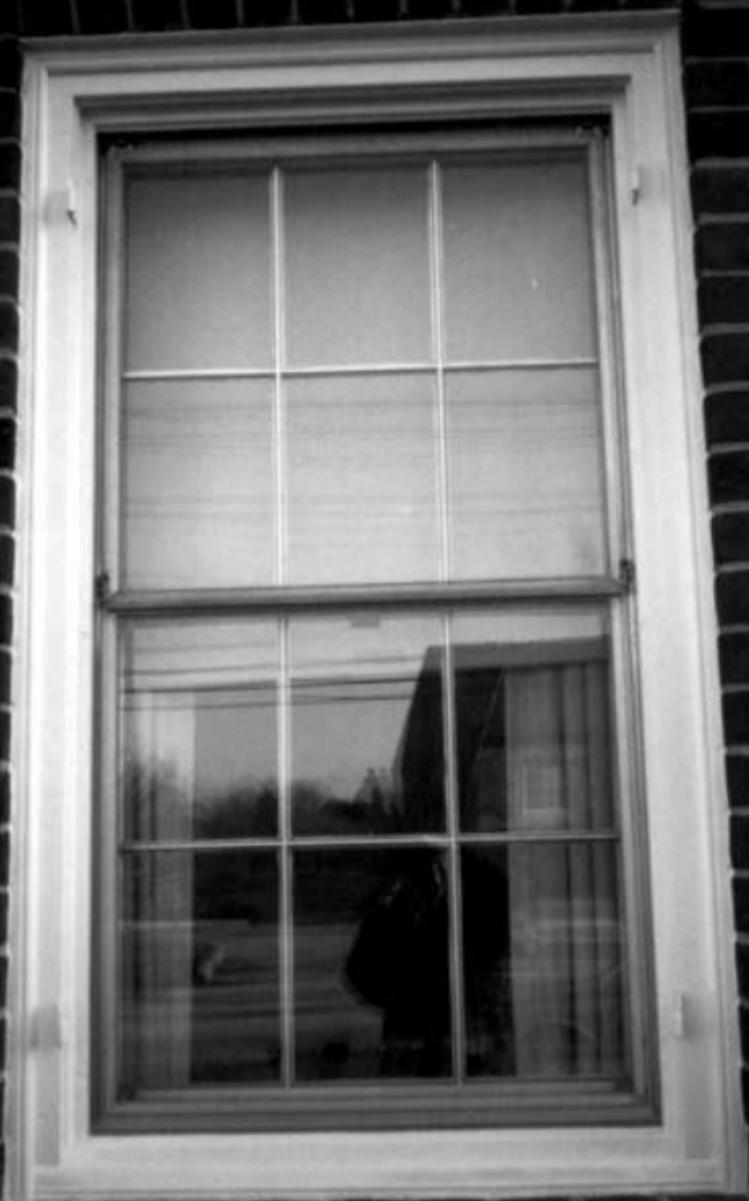
(14)

DETAIL OF WINDOW
